THE VERY BEST OF BRITISH RAIL

Superb craftsmanship that created railings at the National History Museum came under scrutiny during a frontage project in London, writes **Chris Topp**

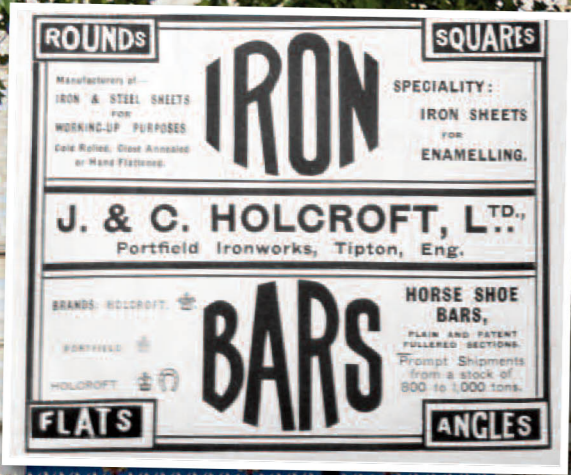
Main picture: the Natural History Museum railing after the completion of the project. Above: One of a number of iron-maker's stamps. Top: an advertisement from the Portfield Ironworks – makers of at least some of the wrought iron

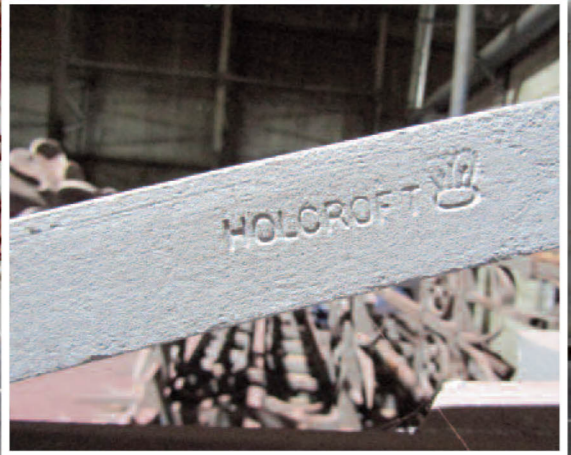
such that we can say that they were made by superb craftsmen from puddled wrought iron and that the designer was fully conversant with the art of the smith. There are various marks stamped into the iron, which, owing to the presence of crowns in most cases, can be taken to denote the various iron manufacturers, rather than the smith. Further research into these marks might well prove fruitful in identifying at least the area in which the railings were made. Certainly the mark "Holcroft" is from the Portfield ironworks of

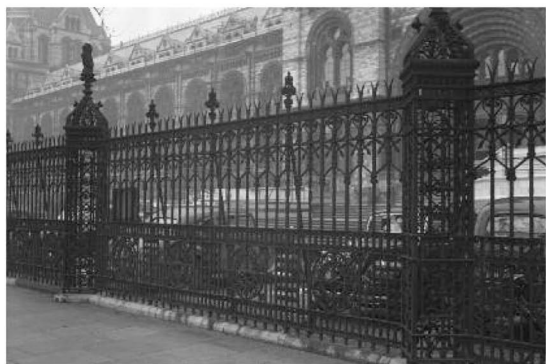
Waterhouse Building: Railing at the main entrance on Cromwell Road in 1951

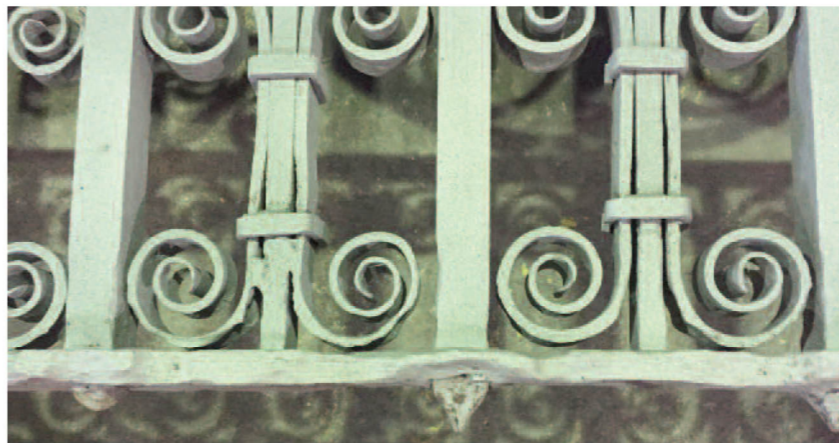
Above: Typical corrosion of bottom scrollwork.
Right: photographs showing the railings after the completion of the Natural History Museum project earlier this year

Where remedial work was required, for example where corroded bottom rails and scrollwork were in need of replacement, the work has been guided by the National Heritage Ironwork Group's Conservation Principles, as published on their website www.nhig.org.uk. Examples would be replacements made in

original type materials – puddled iron was used throughout. Replacement elements were created by forging and forge welding etc as per the original techniques.

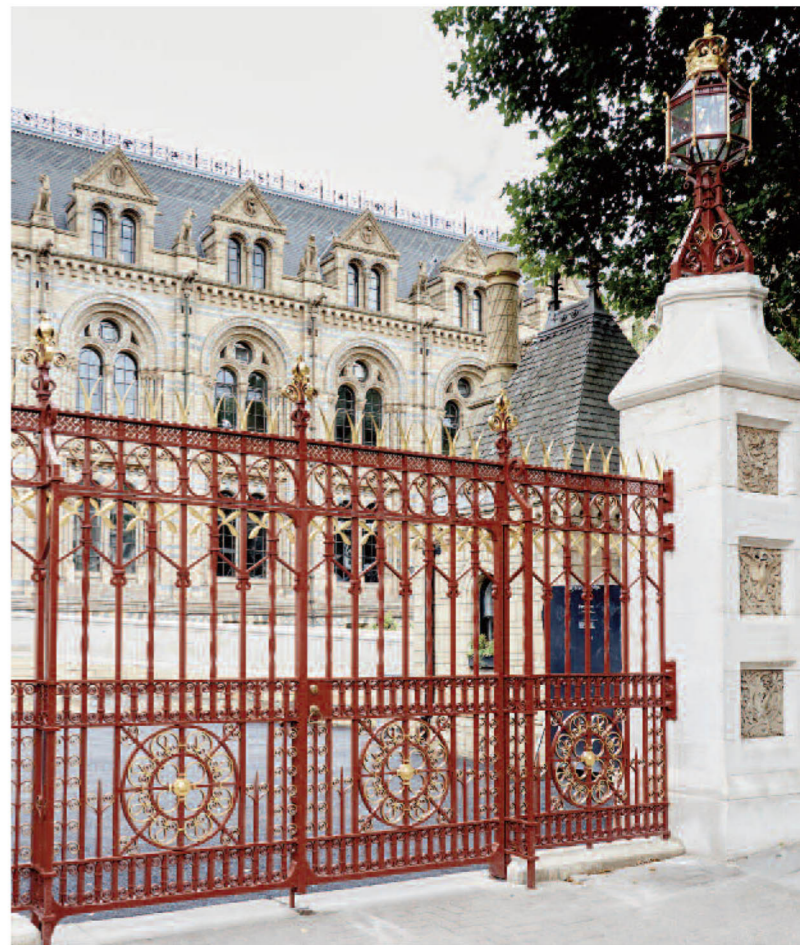
Considering the age of the railings – 136 years – they are in good condition, significant loss of metal through corrosion has occurred in only a few places, notably where water can lodge between iron and stone. This is consistent with our experience elsewhere with wrought iron, which, with reasonable maintenance will last indefinitely. The Natural History Museum ironwork has definitely been well maintained. Paint analysis proves that there have been as many as 17 re-decorations. There have been many different colour schemes, but the original colour seems to have been an orange brown, pigmented with iron oxide. Photographs of the railings from the 1930s

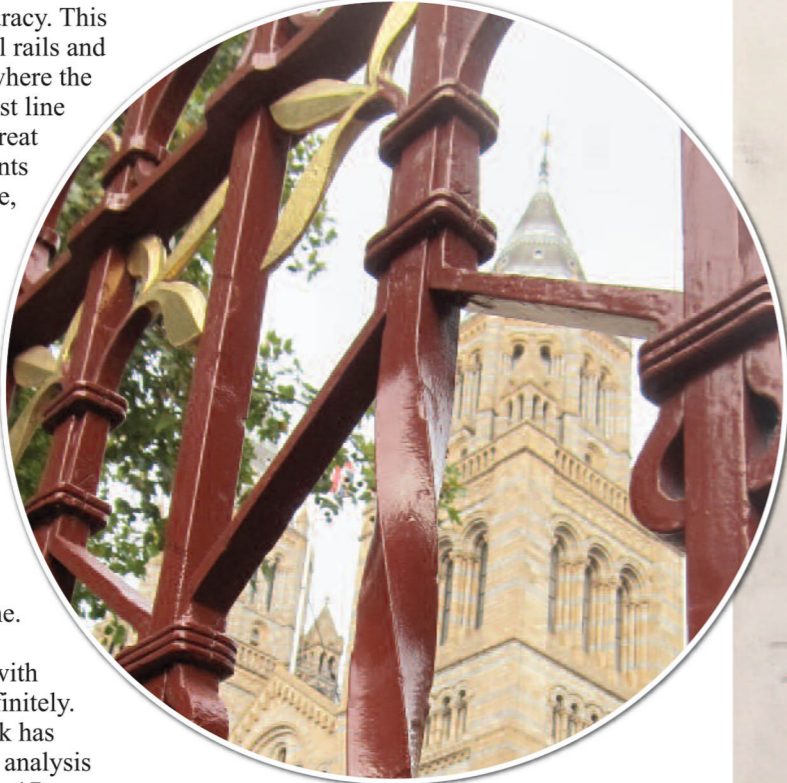
Above: Second World War shrapnel damage left intact. **Right:** Original concept sketch by Alfred Waterhouse showing initial idea for lanterns

The Museum was hit by several bombs during the Second World War, as evidenced by numerous examples of damage to the ironwork by flying shrapnel. There is evidence that several panels of the railings were partially destroyed and have been reconstructed. Interestingly, the construction methods used after the war were not altogether up to the standard of the Victorian originals, there being some use of electric welding, but by modern standards they were not too bad. Despite the use of a good deal of cast bronze rather than forged iron, the work was good enough to largely pass unnoticed and hence has been left intact in the current conservation. Where there is evident damage by shrapnel, holes and gouges in the otherwise undamaged original ironwork, these have been left unrepaired as an interesting part of the history of the railings.
